RP-501 / RP-500

Reduced Pressure Assembly

First All Composite Reduced Pressure Backflow Preventer in The World!

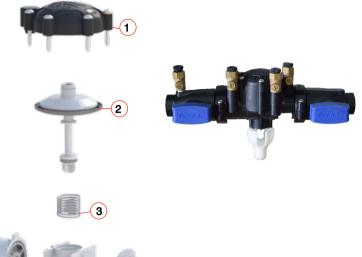
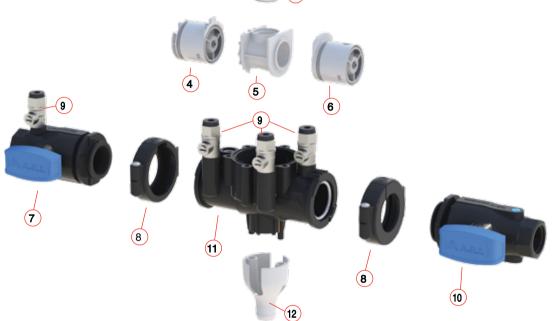
Parts List & Description

No. Part Description

- 1. Cover Assembly
- 2. Relief Valve Assembly
- 3. Relief Valve Spring
- 4. Inlet Check Valve Assembly #1
- 5. Retainer
- 6. Outlet Check Valve Assembly #2
- 7. Inlet Shut-Off Valve
- 8. Clamp Assembly
- 9. Test Cocks (#1, #2, #3, #4).
- 10. Outlet Shut-Off Valve
- 11. Body Assembly
- 12. Funnel
